McKinley Creek-Frontal Lake Erie  
HUC-12: 041100030204  
Nine-Element  
Nonpoint Source Implementation Strategic Plan (NPS-IS Plan)

Approved May 22, 2017

Version 1.0  
April 3, 2017

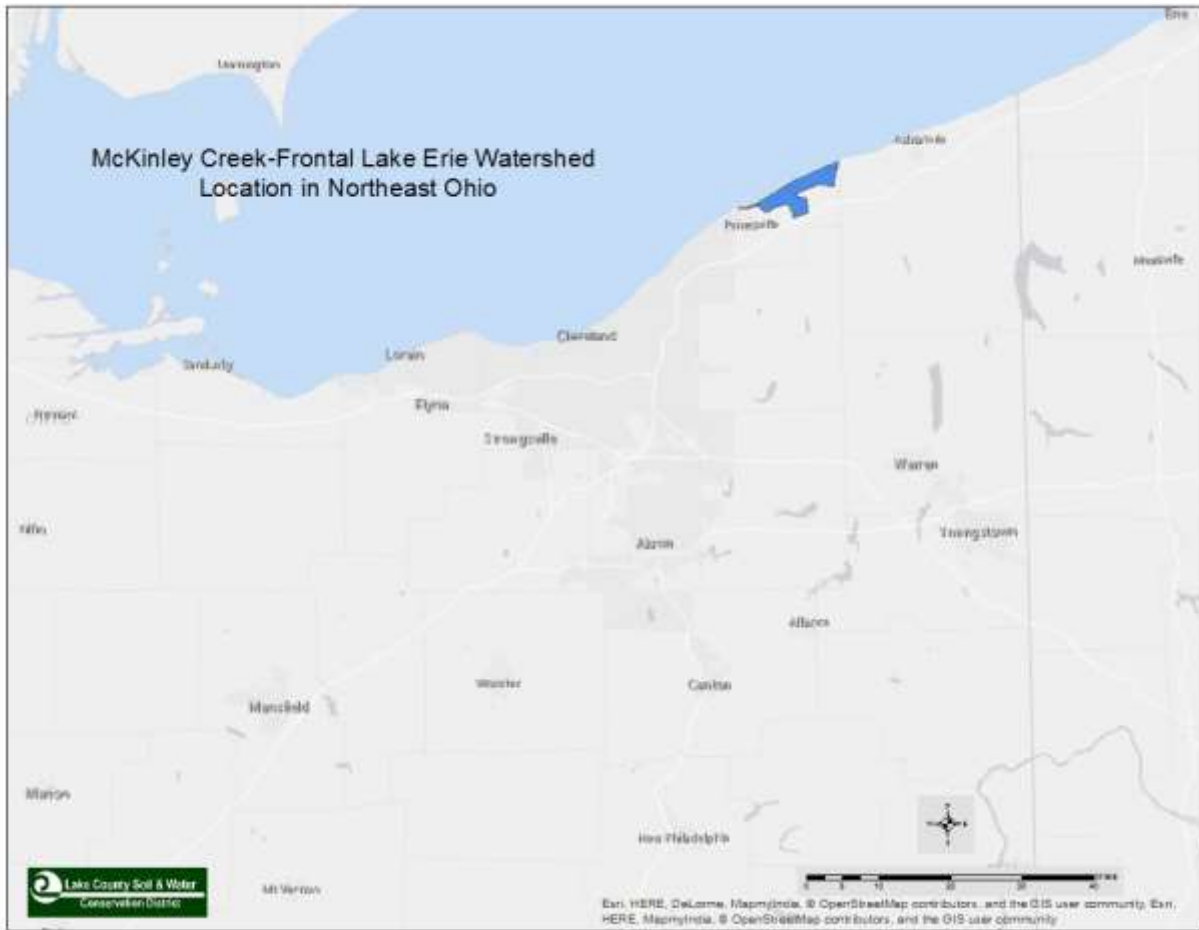
**Figure 1. Location of Watershed**

The McKinley Creek-Frontal Lake Erie Watershed is located in northeastern Lake County in Northeast Ohio, directly on the Lake Erie shoreline (Figure 1). It is bounded to the north by Lake Erie, to the west and south by the Grand River Watershed and to the east by the Arcola Creek Watershed. It drains approximately 29.7 square miles into the Great Lakes Basin. The McKinley Creek-Frontal Lake Erie Watershed 12 digit Hydrologic Unit Code (HUC) is 041100030204.

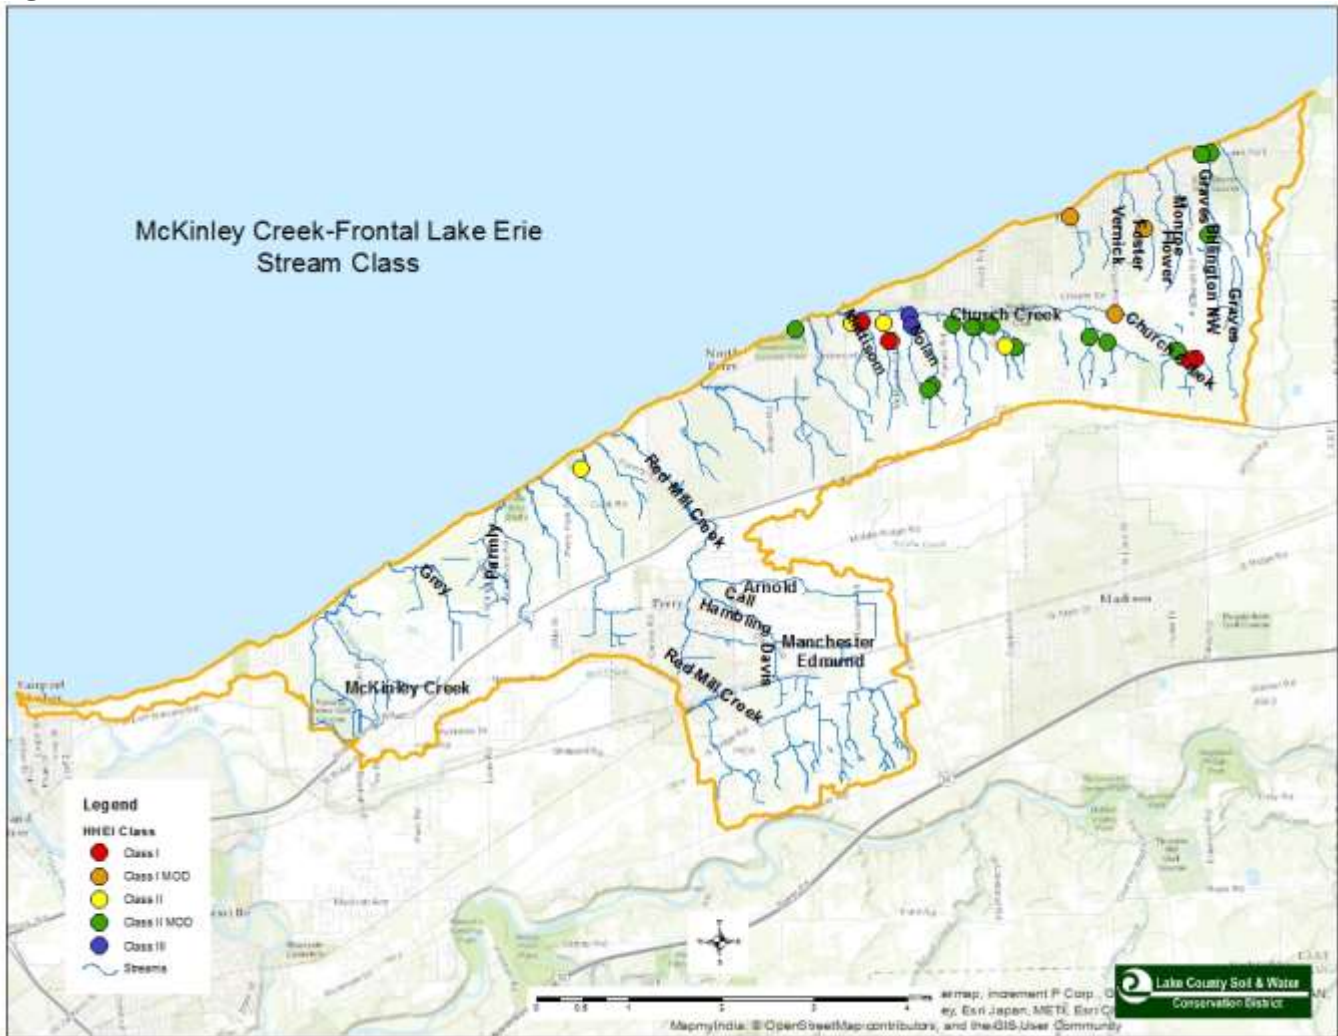
**Figure 14. Stream Class**

Class	%
Class I	14
Class I Modified	11
Class II	18
Class II Modified	50
Class III	7
	100

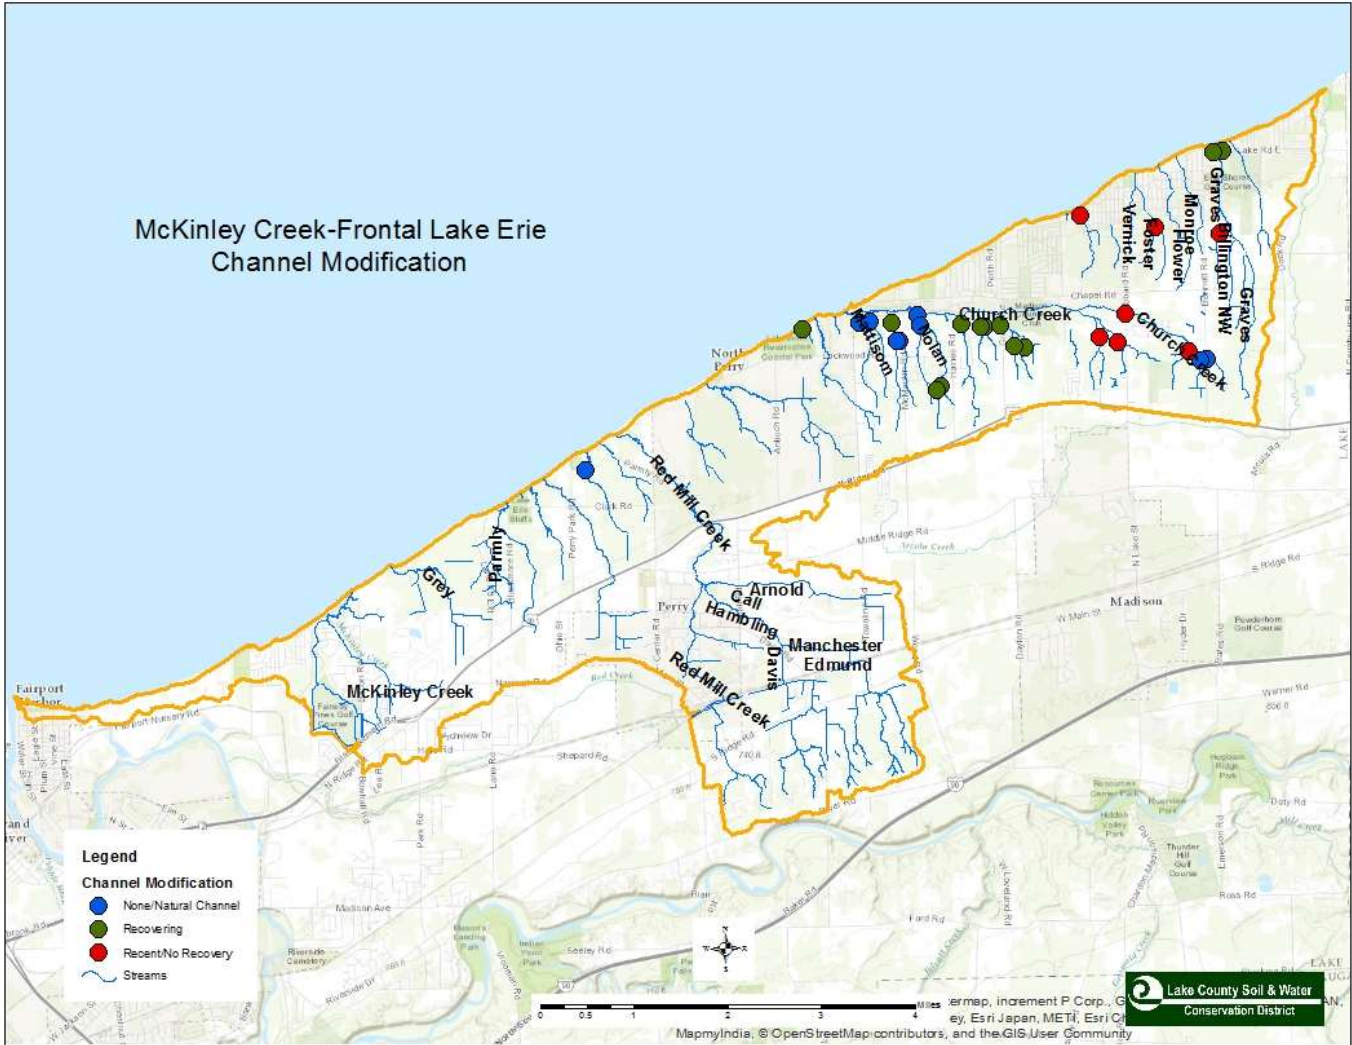
**Figure 17. Channel Modification**

Channel Modification	%
None/Natural Channel	32
Recovering	43
Recent/No Recovery	25
	100

When the HHEI assessment was done in 2007, 25% of the channels were identified as recent with no recovery, and 75% as recovering or natural channel. Figures 18, 19 and 20 illustrate the different stream classifications within the watershed.

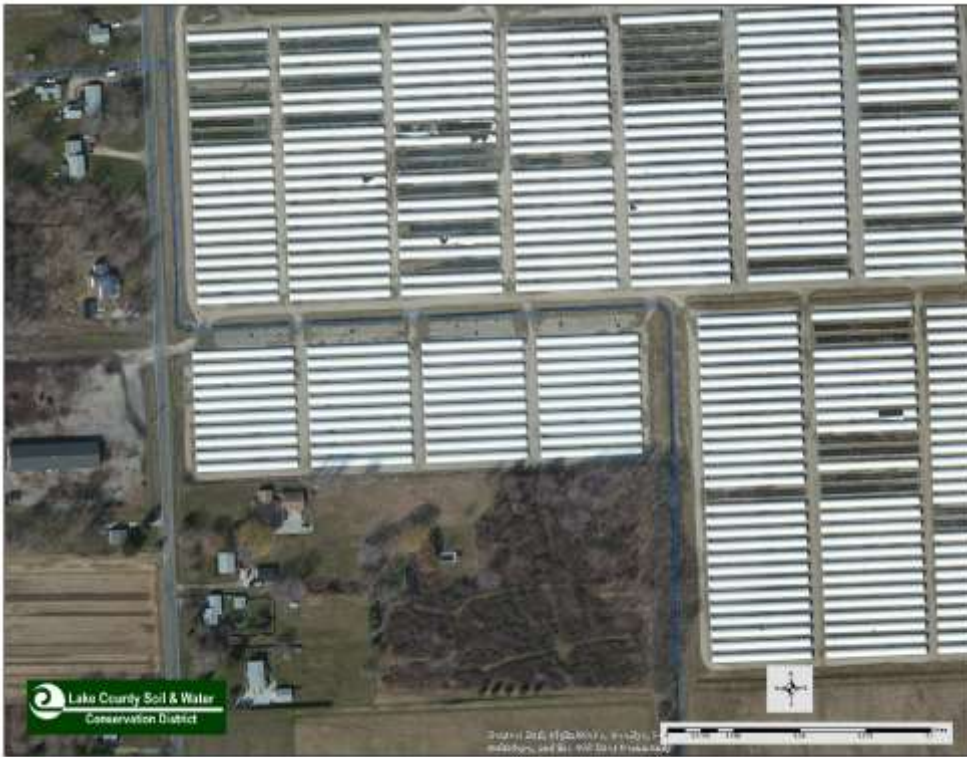
**Figure 21. Stream Modified in Nursery Land Use**

Many of the waterways in this watershed have been historically modified and treated as ditches, to remove poorly draining water from developed land uses, where residents have experienced flooding and standing water, and from nursery land uses (Figures 21 and 22).

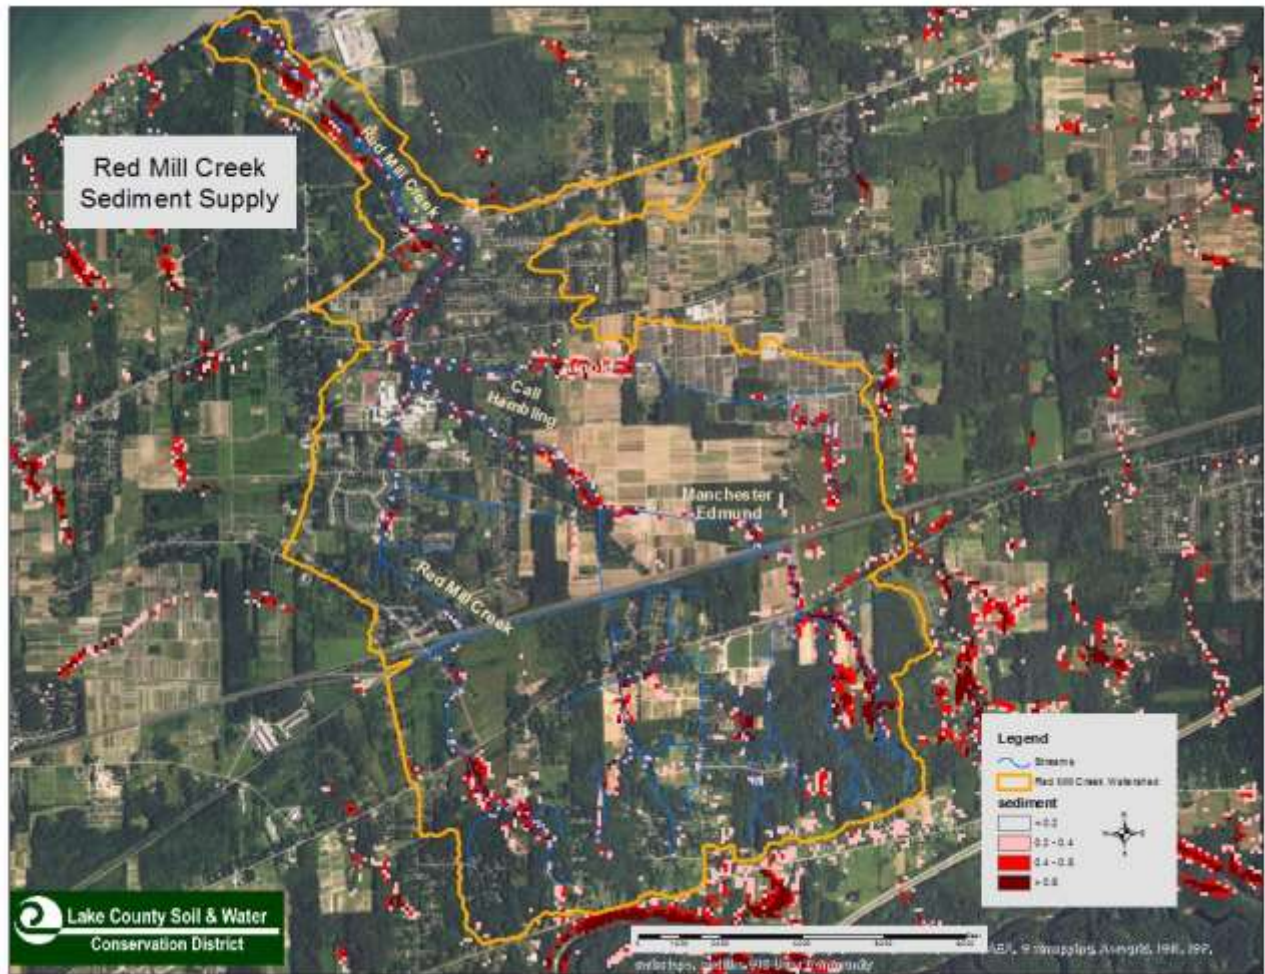
Figure 26. Red Mill Creek Sediment Supply

The US Army Corps of Engineers did a field assessment of streams in the McKinley Creek- Frontal Lake Erie Watershed in 2015, by using its Stream Channel Sediment Supply Assessment protocol. The Lake County Soil & Water Conservation District Watershed Coordinator assisted the Corps staff in the data collection.

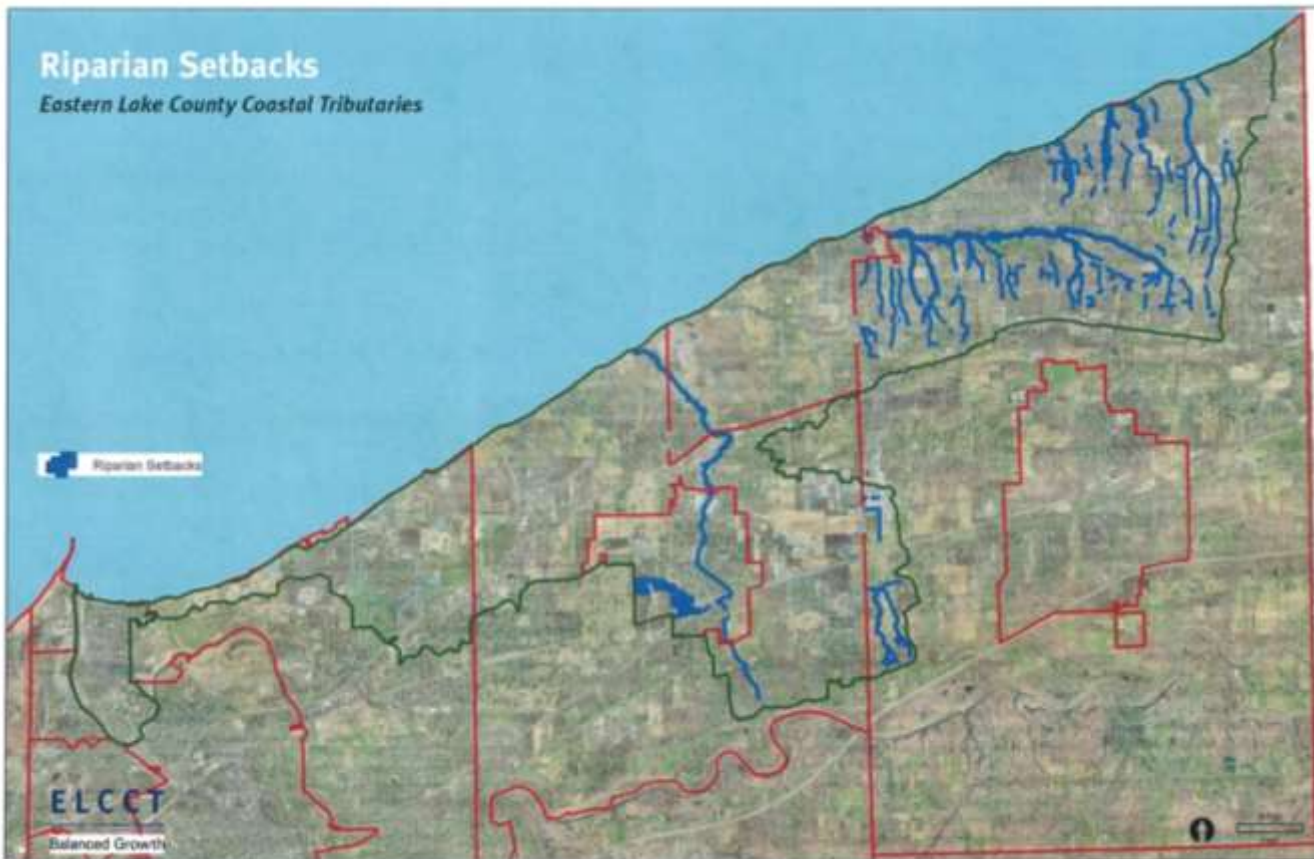
**Figure 28. Riparian Setbacks, ELCCT Balanced Growth Plan**

Madison Township, Perry Village and North Perry Village have incorporated riparian setbacks into their zoning; Perry Township has setback zoning along two of the major riparian corridors (Figure 28).

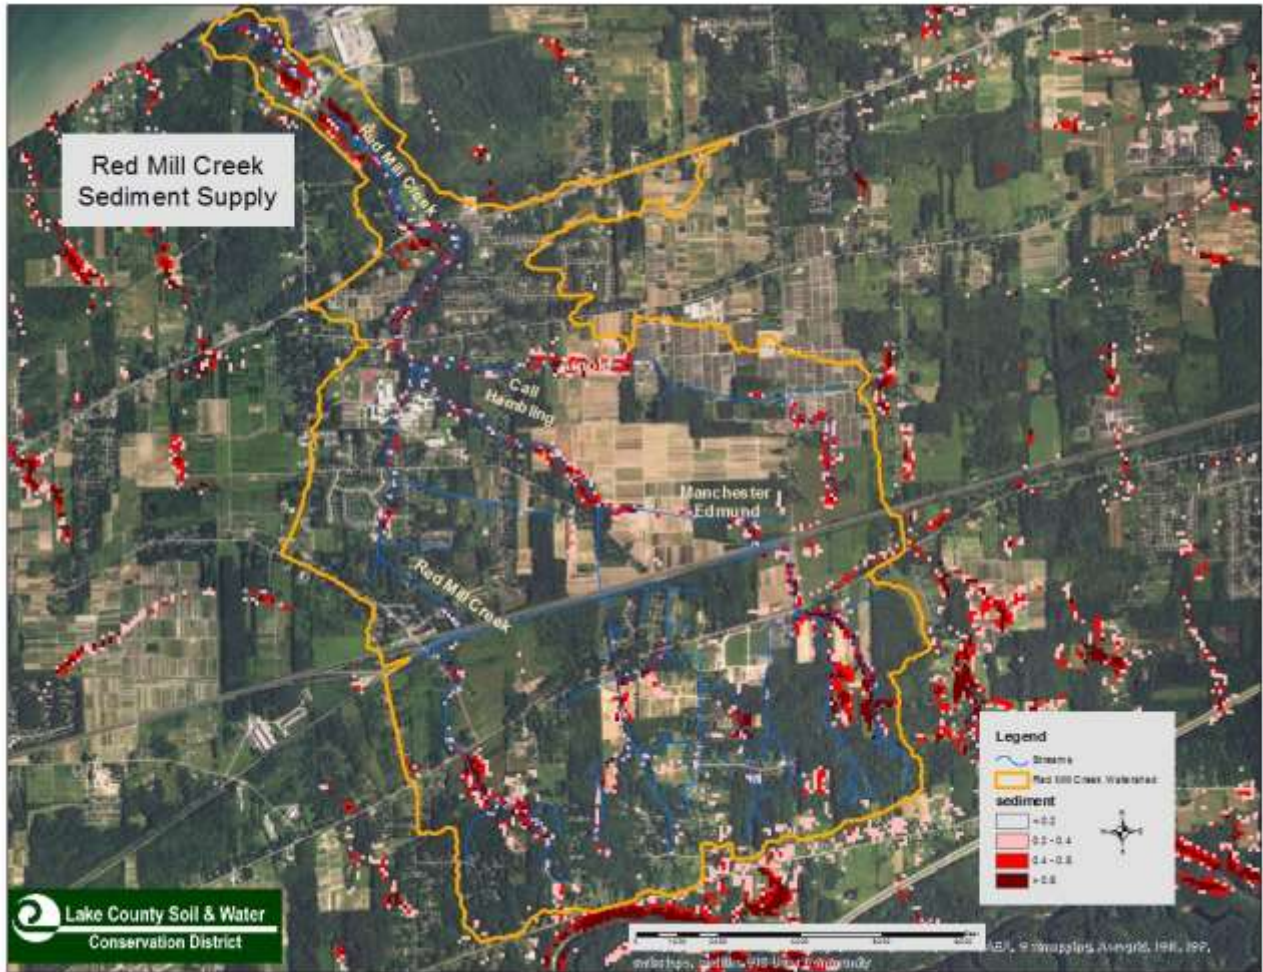
**Figure 36. Red Mill Creek Sediment Supply**

The 2015 U.S. Army Corps of Engineers field stream assessment generated data of erosion and sediment potential in the watershed. Figure 36 shows areas of higher erosion along many of the tributaries and main stem of Red Mill Creek. Total Suspended Solids (TSS), a measure of soil sediment in the water column was measured using the Ohio Sediment Stick. The water quality rating was found to be Impaired in six locations (Figure 37 & 38). Several of these areas have been identified as project areas.

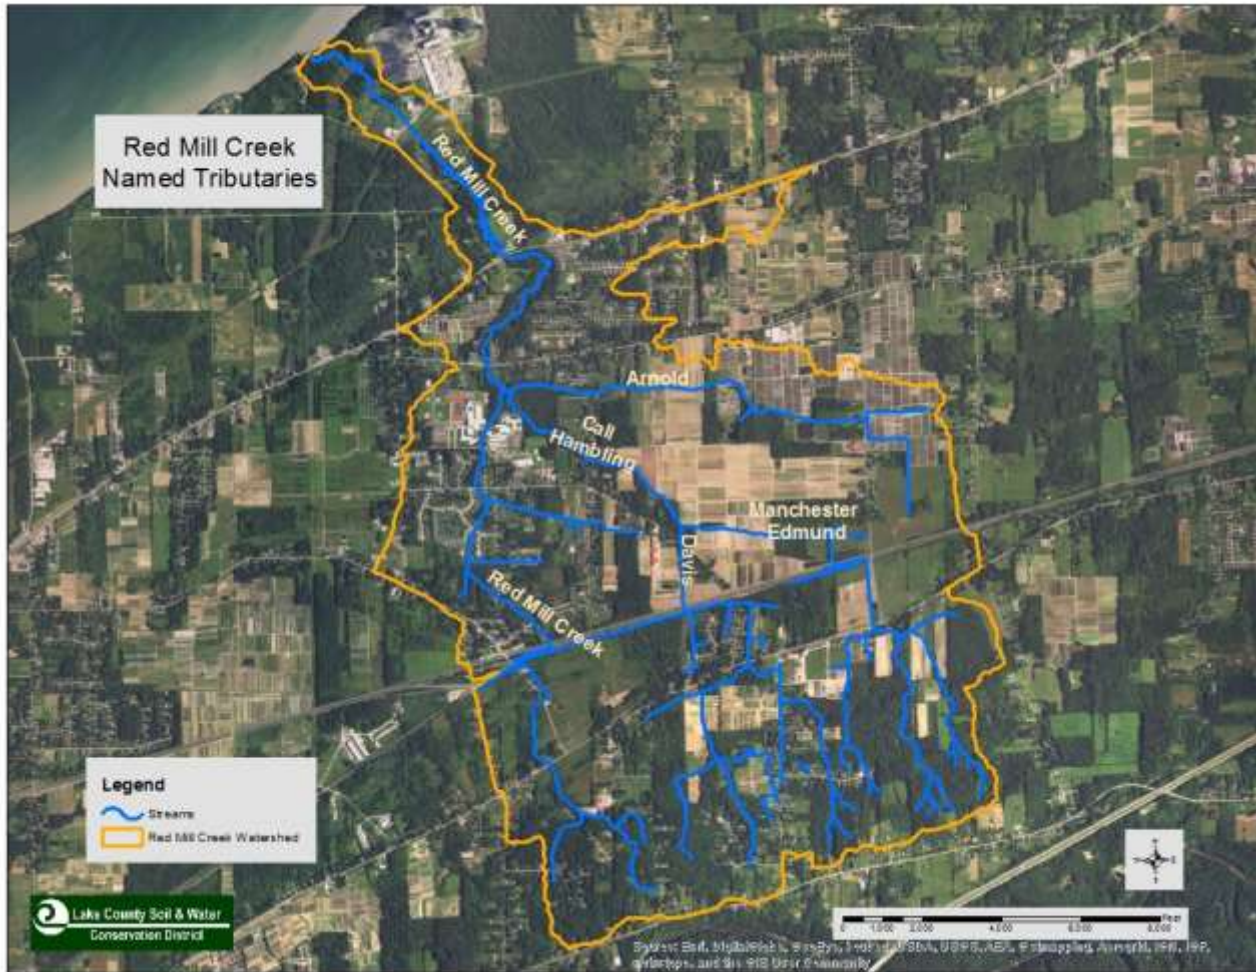
**Figure 39. Red Mill Creek Named Tributaries**

Several of the tributaries are named (Figure 39).

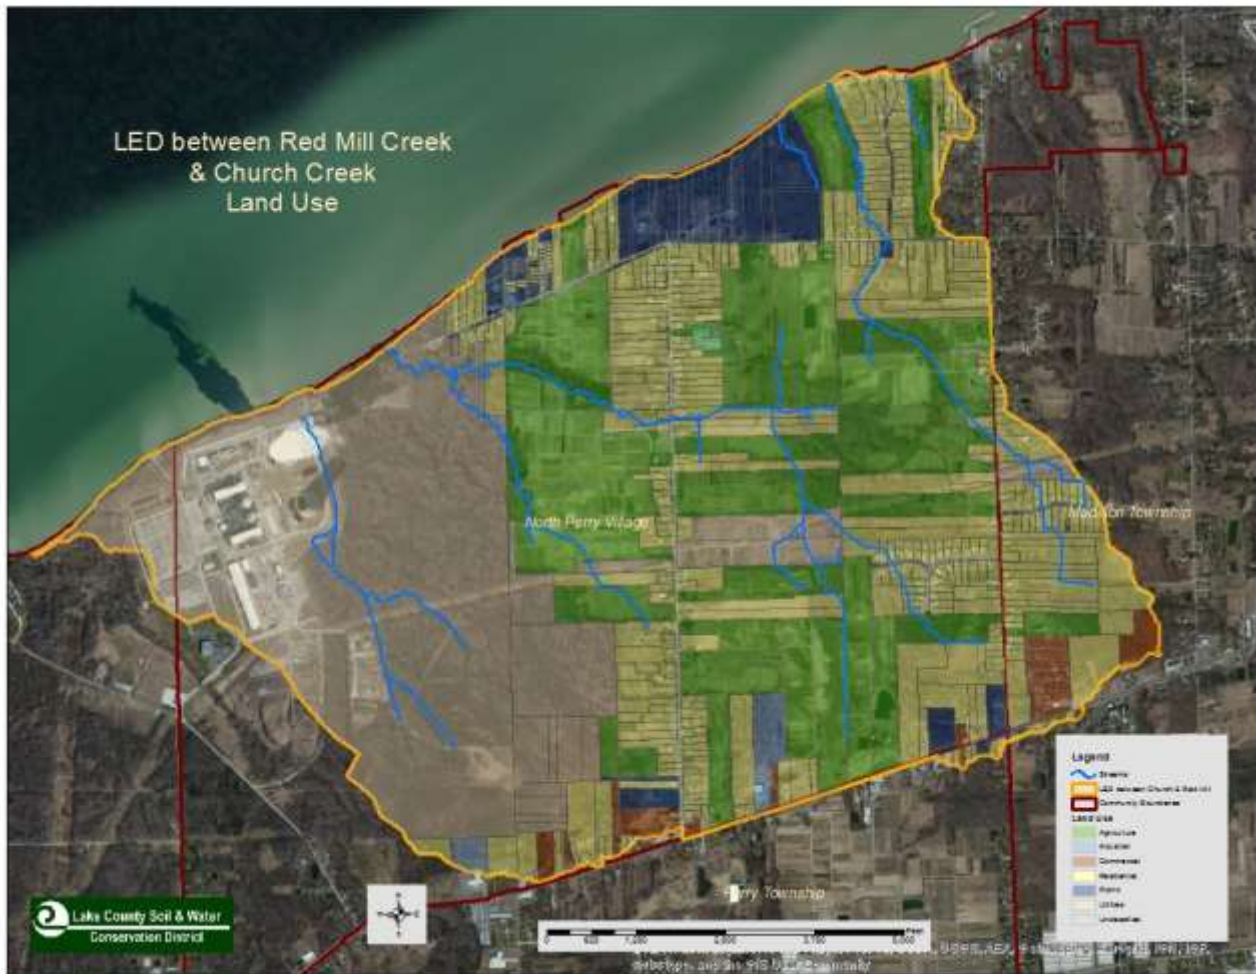
Figure 43. Lake Erie Direct between Red Mill & Church Creek Land Use

The western portion of the watershed contains the First Energy Nuclear Power Plant, a large part of which is forested. The remainder of the land use is balanced between residential and agricultural (Figure 43). The streams in the residential and agricultural areas have been modified and buried in some instances to drain the land. North Perry Village has designated an agricultural preservation area, and currently has 170 acres protected with agricultural easements. The agricultural land uses are nursery and vegetable production.

Note the shadow of the steam from the nuclear power plant cooling tower on Lake Erie.

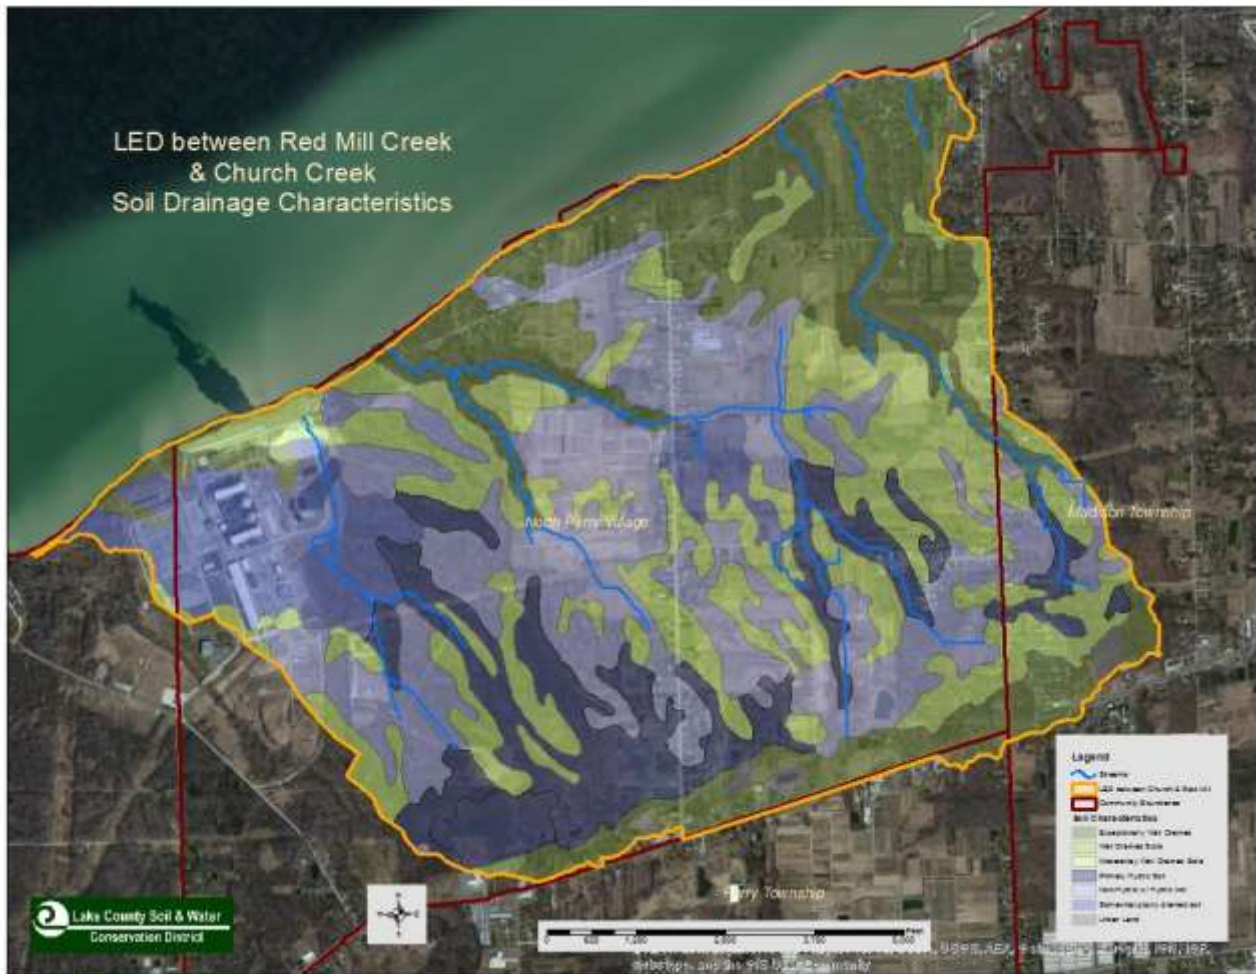
Figure 44. Lake Erie Direct between Red Mill & Church Creek Soil Drainage Characteristics

Nearly half of the soils are exceptionally or moderately well drained and the other half has hydric drainage characteristics (Figure 44).

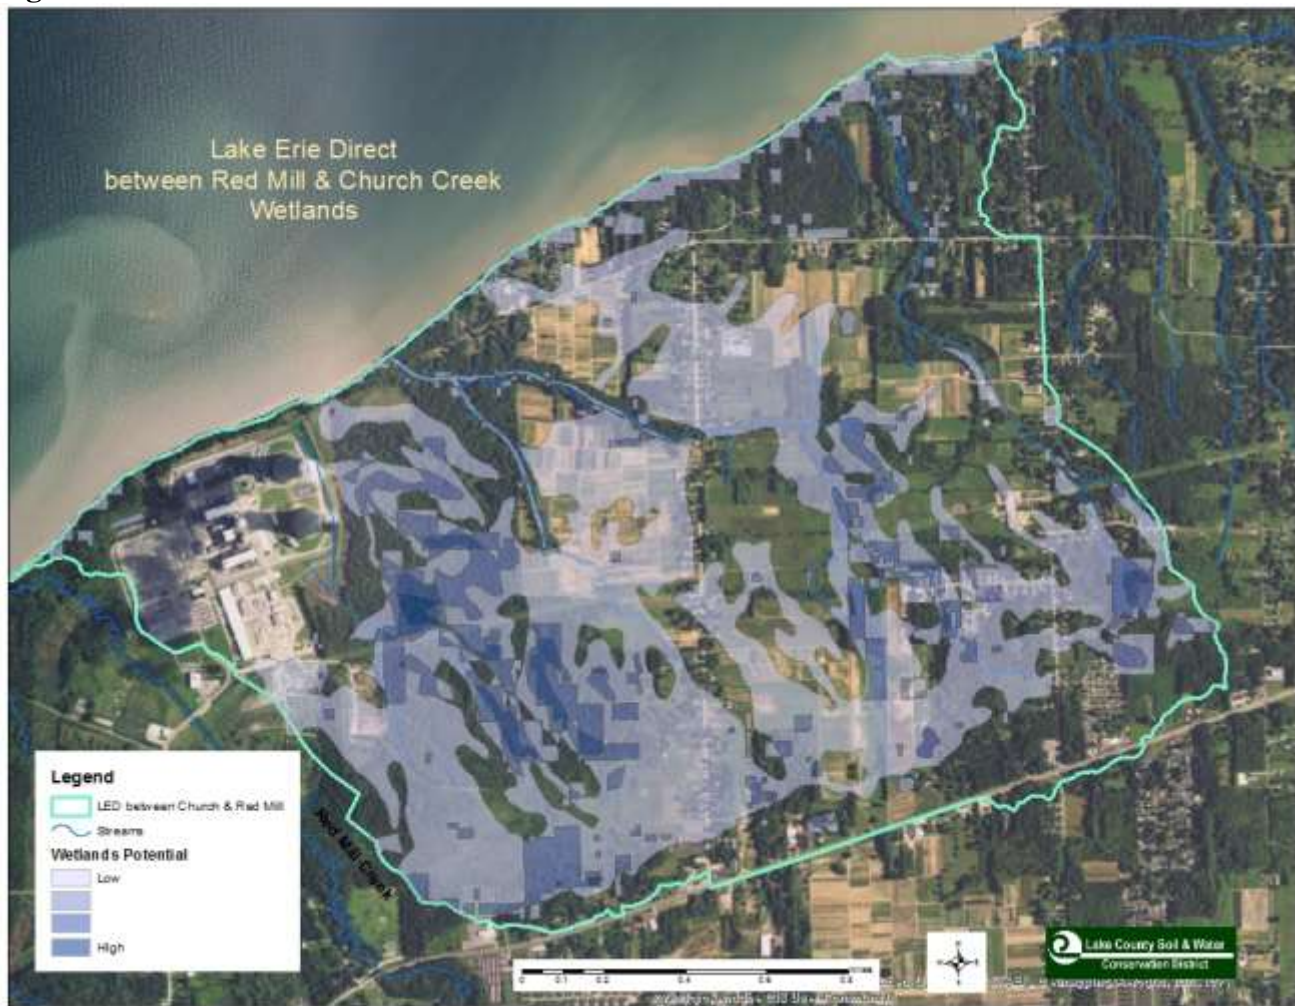
**Figure 45. Lake Erie Direct between Red Mill & Church Creek Wetlands**

Wetlands are prevalent in this subwatershed (Figure 45). They have been mapped using several different sources of wetland delineations; the darker the color in Figure 43, the greater the likelihood of wetlands being at that location. Many of them have been drained through “ditches” and tile drainage for agricultural purposes, and many are intact in the wooded areas.

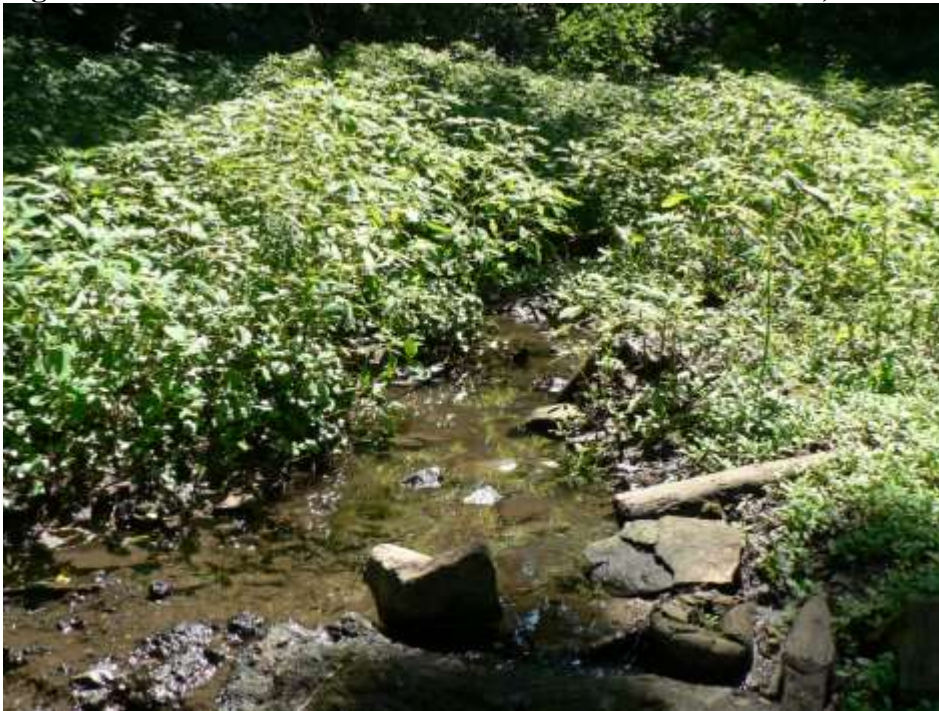
**Figure 46. Lake Erie Direct subwatershed Class II Modified, Recovering**

The Lake Erie Direct subwatershed between Red Mill Creek and Church Creek has been determined a critical even though it has not been assessed in particular by the EPA. This decision was made based on the conditions observed by the stakeholders. The streams have lost their functionality, stability and access to the floodplain. Channels are incised and banks are eroding; instream habitat is severely limited because of poor morphological development and low stability.

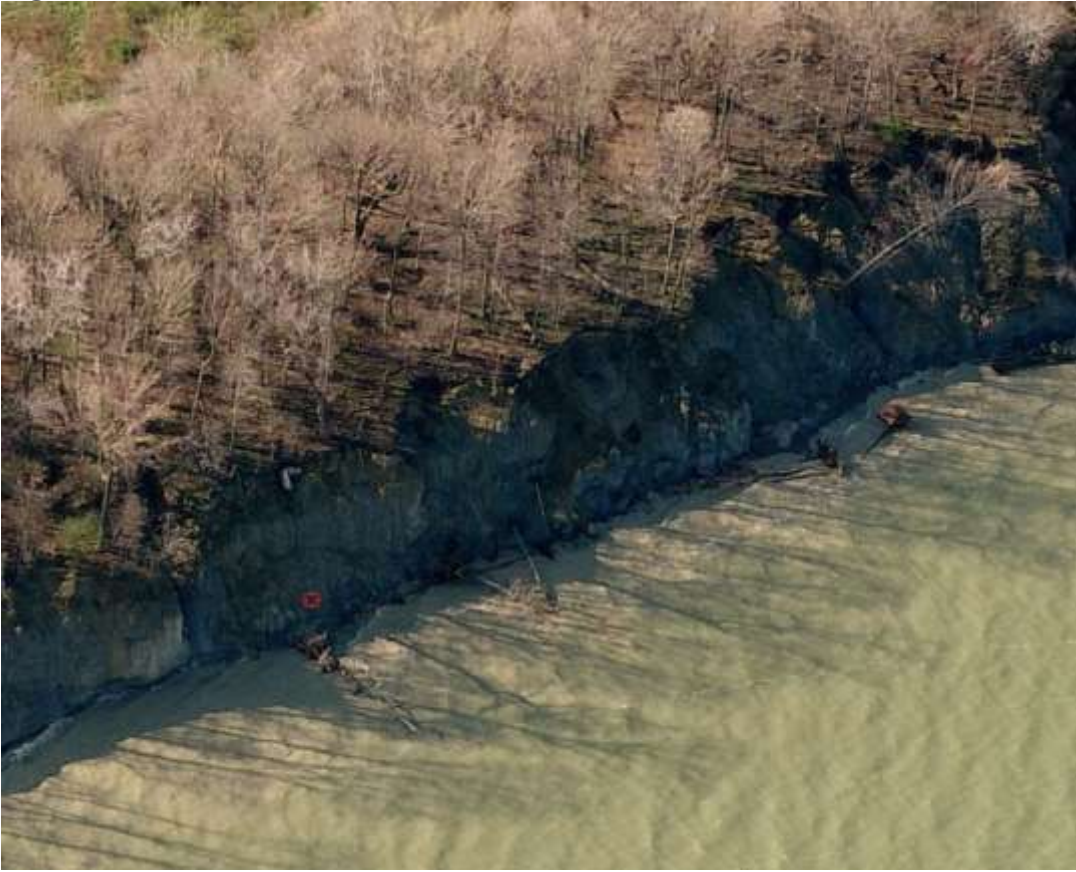
**Figure 51. Lake Erie Bluff**

The watershed is on the Lake Plain and the elevation drops from 706' at the top of the watershed to 572' at the Lake level, for a 1% average slope. The "ridge" from a former lake level elevation and which forms North Ridge Road is visible on a topographical map running parallel to the lake in the southern of the third of the watershed (Figure 50). The streams tend to cut their way down to the Lake bluff edge and have deeper channels closer to the Lake (Figure 51).

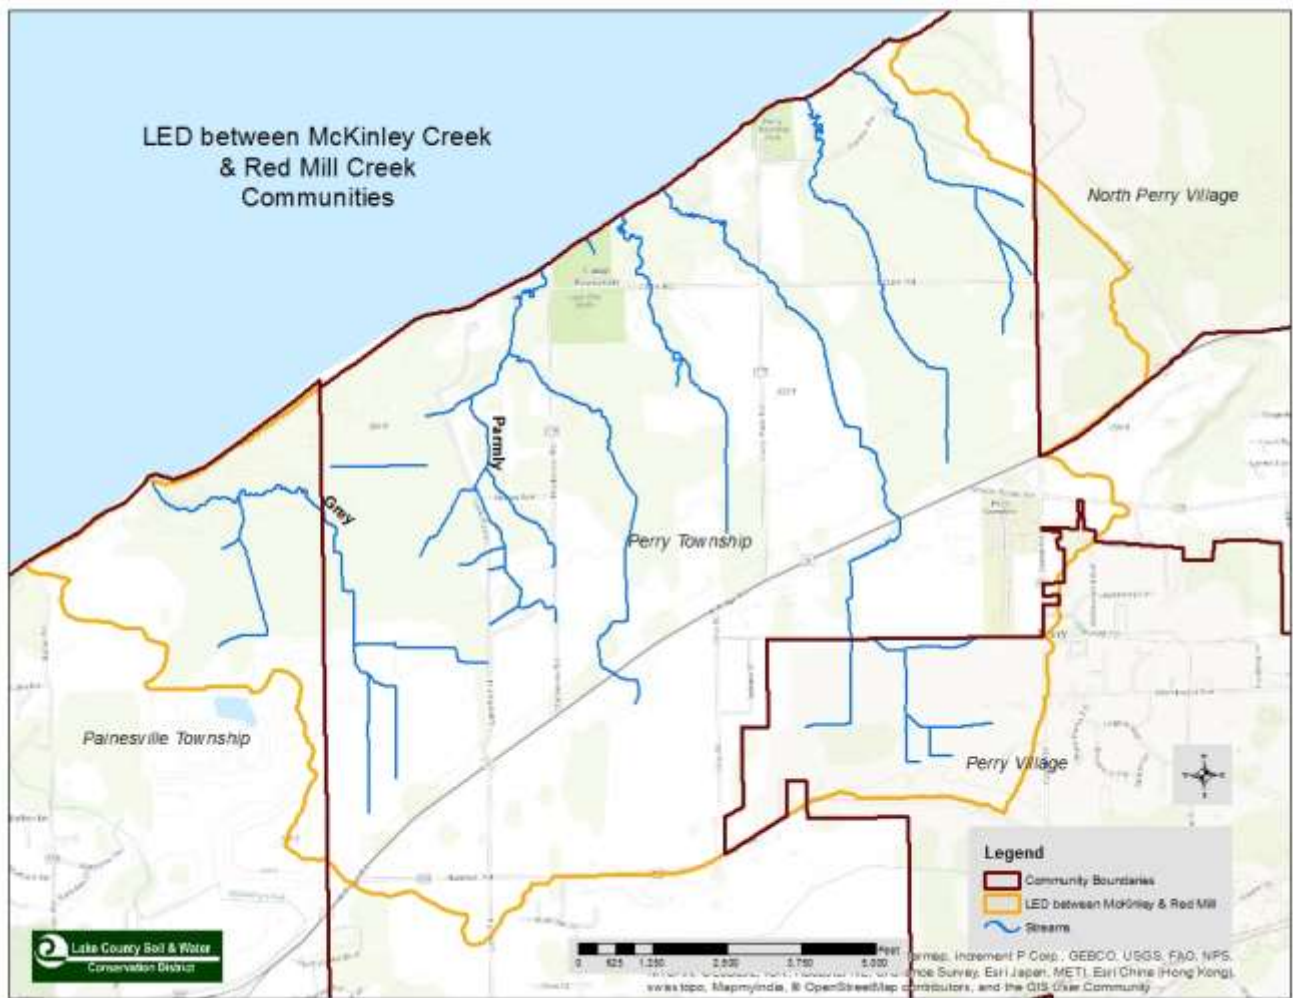
Figure 52. LED between McKinley & Red Mill Creek Communities

The watershed is in portions of Painesville Township, Perry Township, Perry Village and North Perry Village (Figure 52). Perry Township is not in the Lake County Stormwater Management Department, which is a factor when considering funding sources for watershed improvement practices that require a match.

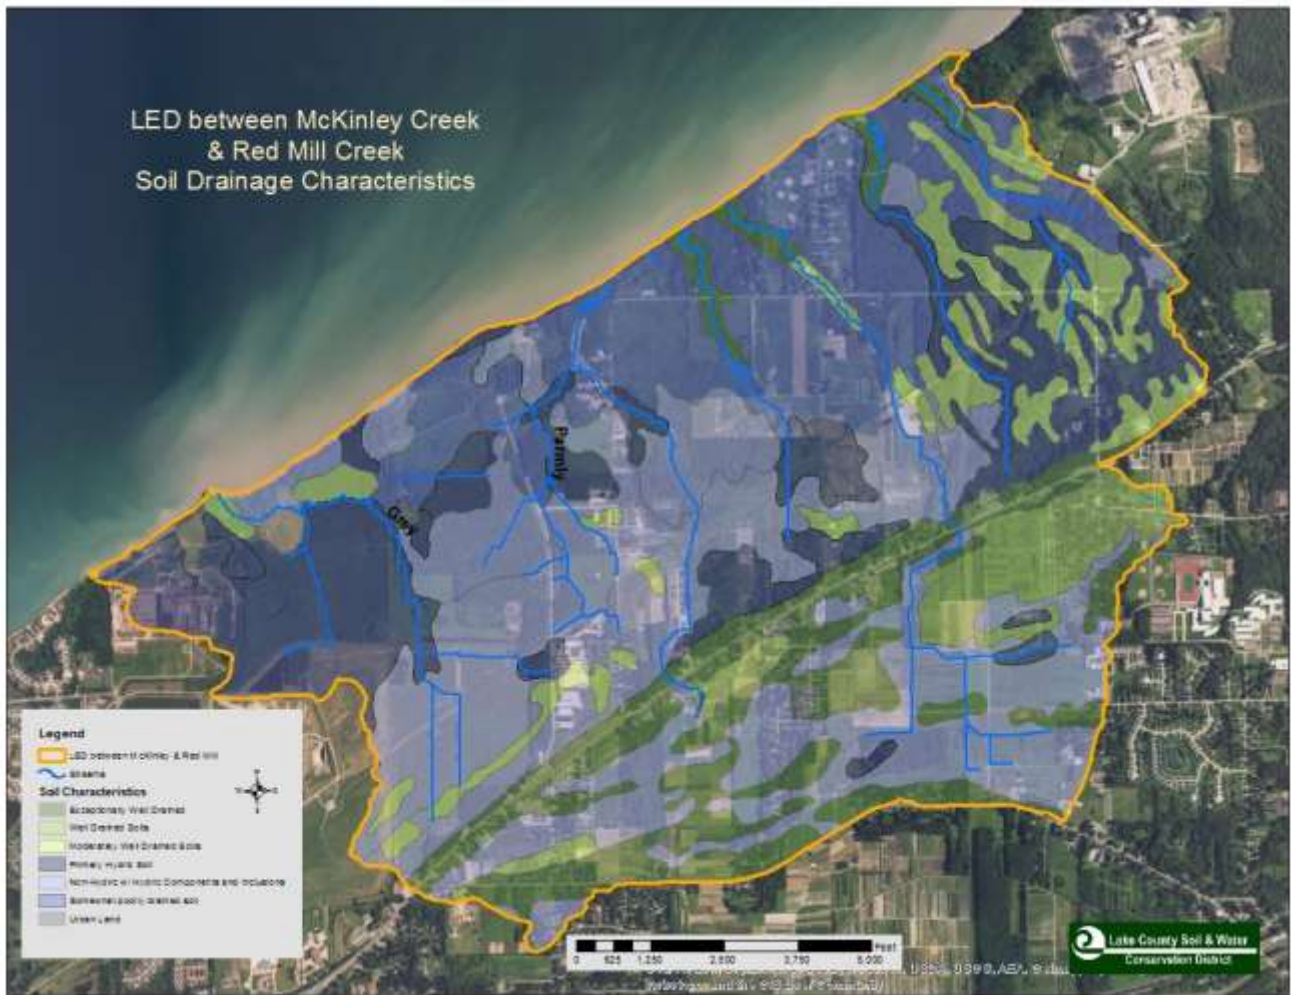
**Figure 55. LED between McKinley & Red Mill Creek Soil Drainage Characteristics**

Soil Drainage Characteristics	Acres	% of Total
Exceptionally Well Drained	508.3	14.2
Well Drained	159	4.5
Moderately Well Drained	304	8.5
Primary Hydric	700.1	19.6
Non-Hydric w/ Hyd. Inclusions	1240	35
Somewhat Poorly Drained	622.5	17.5
Urban	30.4	.7
	<b>3565.7</b>	<b>100</b>
