Marsh Creek- Frontal Lake Erie
HUC-12: 041100030501
Nine-Element
Nonpoint Source Implementation Strategy(NPS-IS)

Version 1.2
September 7, 2023

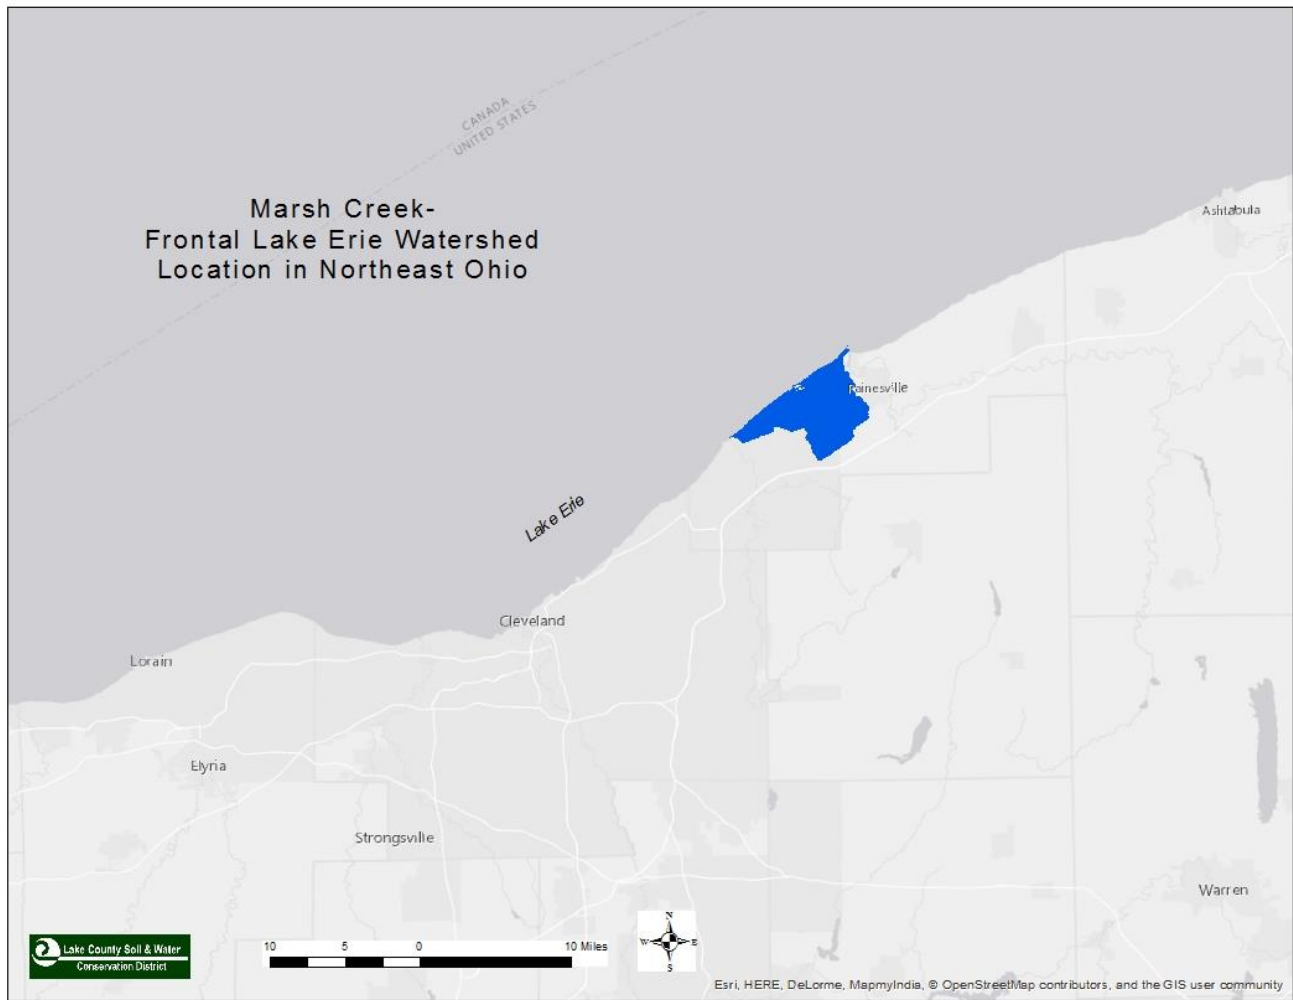
Figure 1: Location of Watershed

The Marsh Creek-Frontal Lake Erie Watershed is located in north-central Lake County in Northeast Ohio (Figure 1). The Hydrologic Unit Code (HUC)-12 is 041100030501. It encompasses the Marsh Creek, Blackbrook, Two Town, and Lake Erie Direct between Grand River and Mentor Marsh subwatersheds. The watershed drains 28.3 square miles. All watersheds drain directly into Lake Erie (Figure 3).

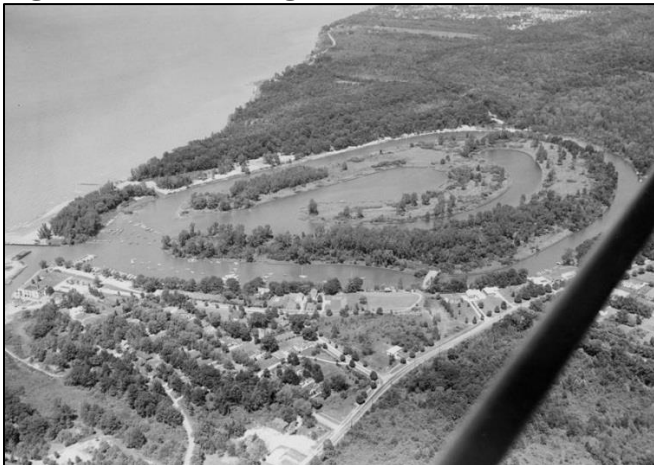
Figure 2: Mentor Lagoons (circa 1957)

The Mentor Lagoons are another feature of the marsh and create a distinctive mark on the landscape (Figure 2). The area was partially developed in the early 1920's by local wealthy residents, as a "Venice of the North." It was never completed and serves today as a marina owned by the City of Mentor.

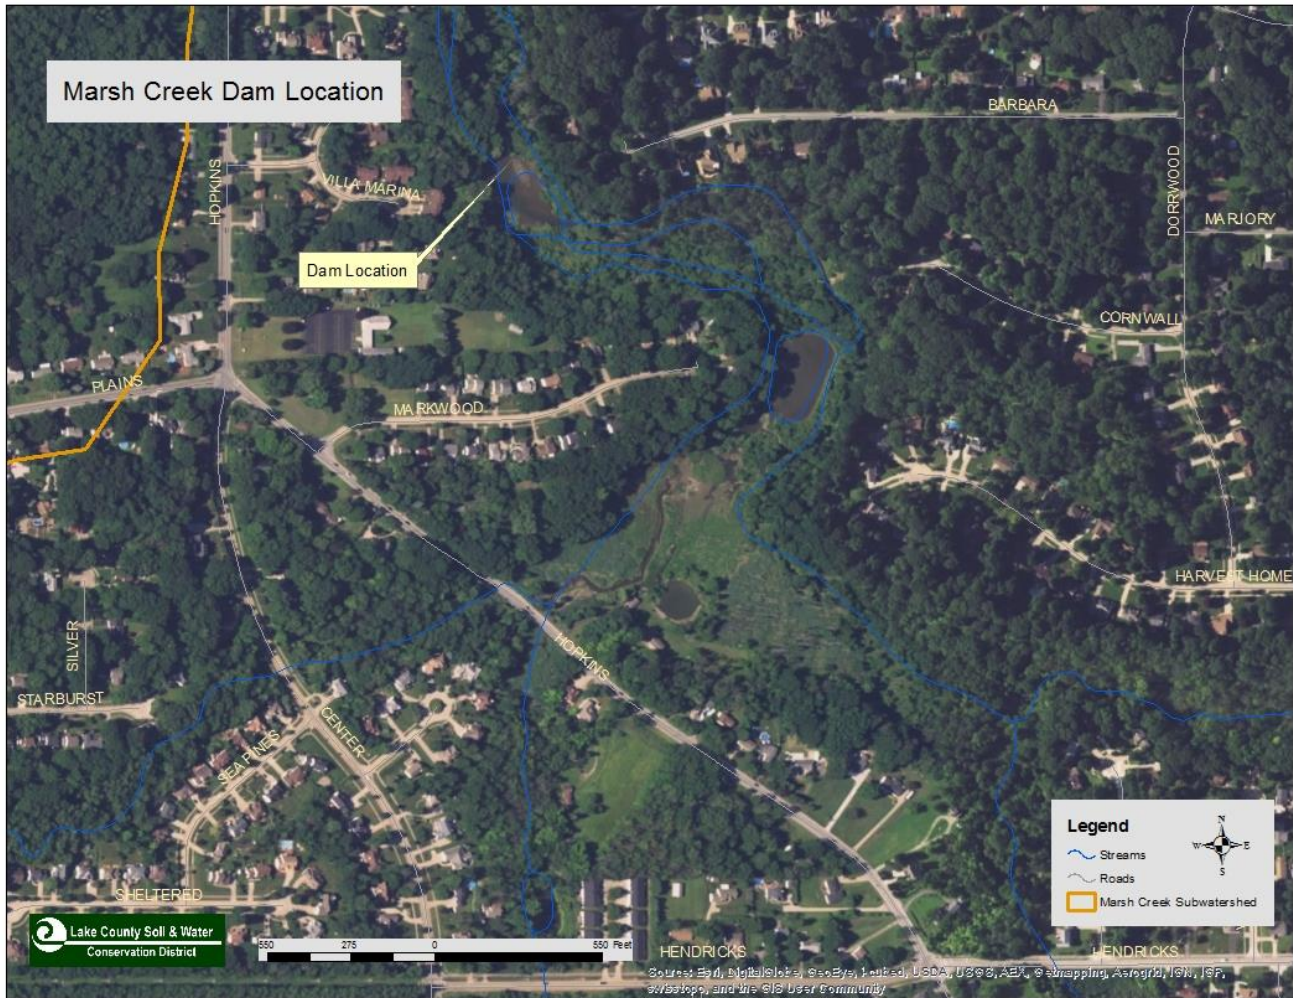
Figure 13: Dam Location

The 2009 ERIN Watershed Report states that there are 3 dams in the watershed, however the stakeholders have identified only one, which is on Marsh Creek north of Hendricks Road and south of Lakeshore Boulevard (Figure 13).

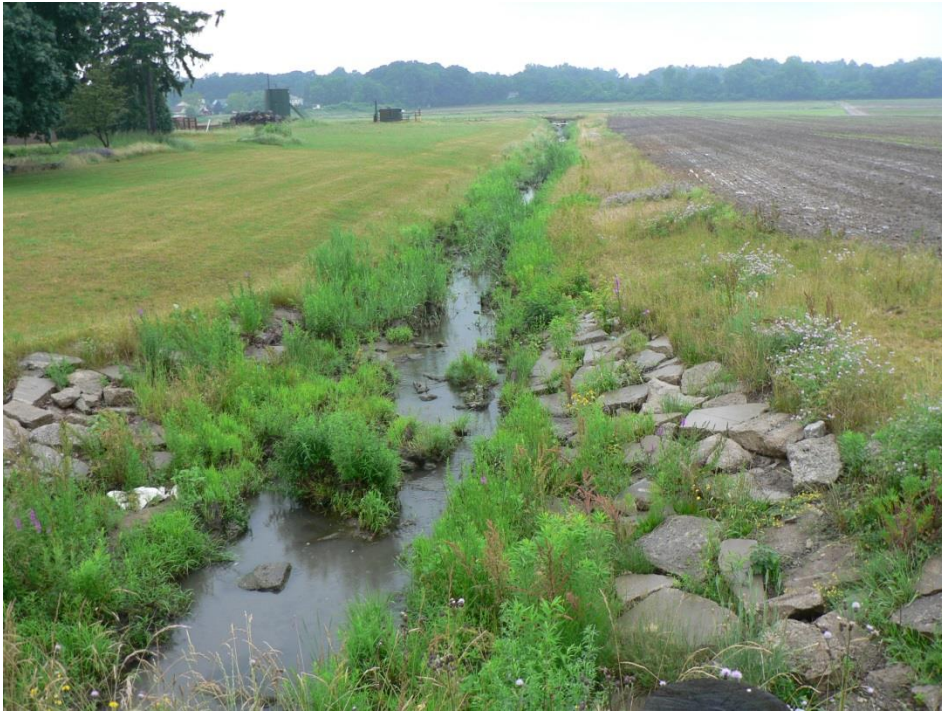
Figure 23: Class I Modified Stream, Recent, No Recovery in Marsh Creek Subwatershed

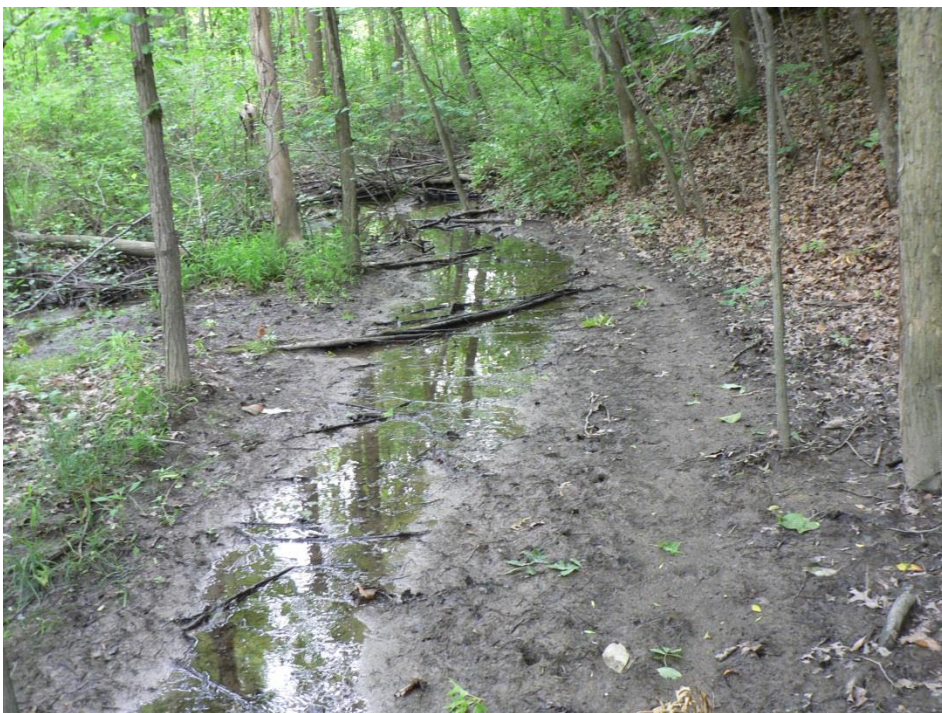
Figure 24: Class II Modified Stream, Recovering in Marsh Creek Subwatershed

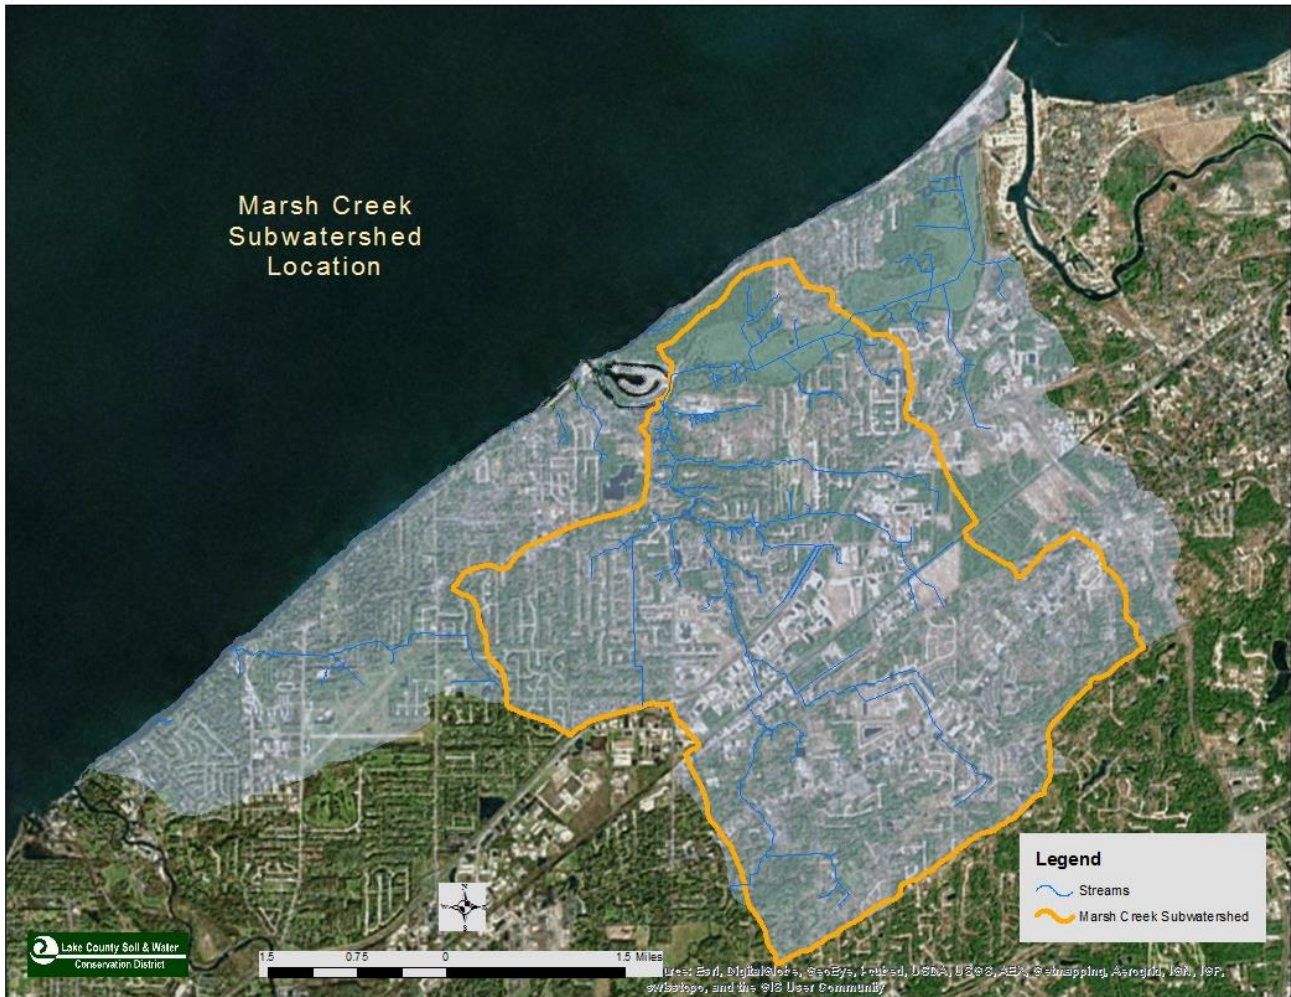
Figure 30: Marsh Creek Subwatershed Location

Marsh Creek drains approximately 10,506 acres or 16.4 square miles. It is located in the central portion of the Marsh Creek-Frontal Lake Erie Watershed (Figure 30). The land use is highly urban, with 53% in residential land uses and 22% in commercial and industrial land uses (Figure 32 and 33). The industrial land uses are clustered in the center of the watershed between SR 2 and the railroad tracks. Most of the commercial enterprises are along SR 20, with some in the industrial corridor. The Mentor Marsh, the ancient watercourse of the Grand River, is bisected by the watershed, and approximately 362 acres of the Marsh are in the Marsh Creek Watershed (Figure 31).
